POLYASPARTIC ZEBRA STRIPES

Case Study – HP Spartacote® Polyaspartic Zebra Stripes

Location: United Kingdom, outside London

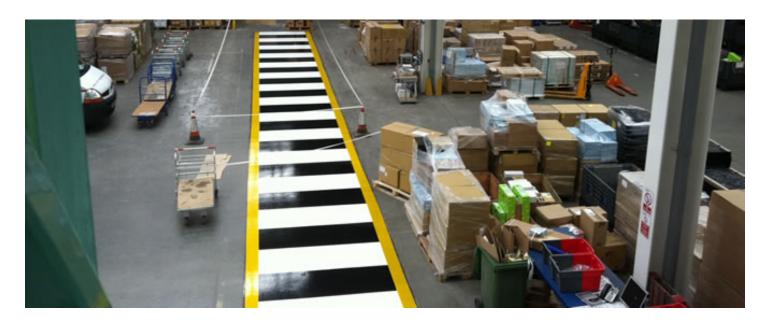
One of the leading automotive parts distribution centers in England. The project called for a standard shop floor coating with a specialized zebra stripe pattern down an elevated center lane. This lane was to also be bordered with safety yellow stripes.

Following the completion of the solid-color coating, the install team taped off and installed the white and black zebra stripes.

Once completed the safety yellow border was applied to the elevated center lane.

Finally, one clear top-coat with traction additive was applied for added durability
