DADE COUNTY-CENTRAL TRANSFER STATION

Project Spotlight

Dade County-Central Transfer Station

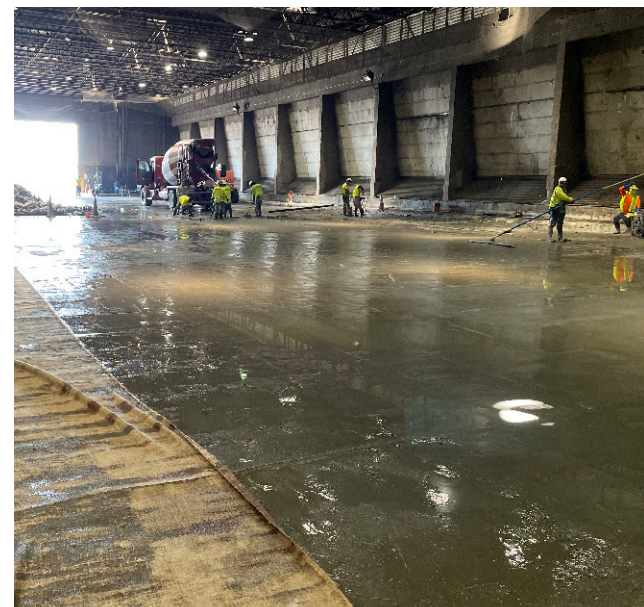
Since the original floor cap needed to be removed, the team began surface preparation procedures by keying in the edges, saw-cutting and chipping out the unbonded areas. Followed by a road-planer with carbide teeth recessing the floor 2 inches (5.1 cm) and leaving a CSP 7 to 9 profile. Once the mechanical surface preparations were completed, it was then washed down with a 5,000 psi (34.5 MPa) pressure washer, ensuring the substrate was clean and ready for the CCS crew to apply L&M EVERBOND™ slurry to bond the soon-to-be-placed L&M EMERYTOP 400 floor topping to the existing prepped substrate.

L&M EVERBOND ensures a high-performance bond between the existing concrete surface and the soon-to-be-applied topping. Once the concrete of the 5,500 square-foot (511 m²) area was demolished and prefilled with high strength concrete, CCS installed a two-inch (5.1 cm) monolithic cap of L&M EMERYTOP 400.
